Power supply problems with some Mark 5A units

MIT Haystack Observatory
16 August 2005

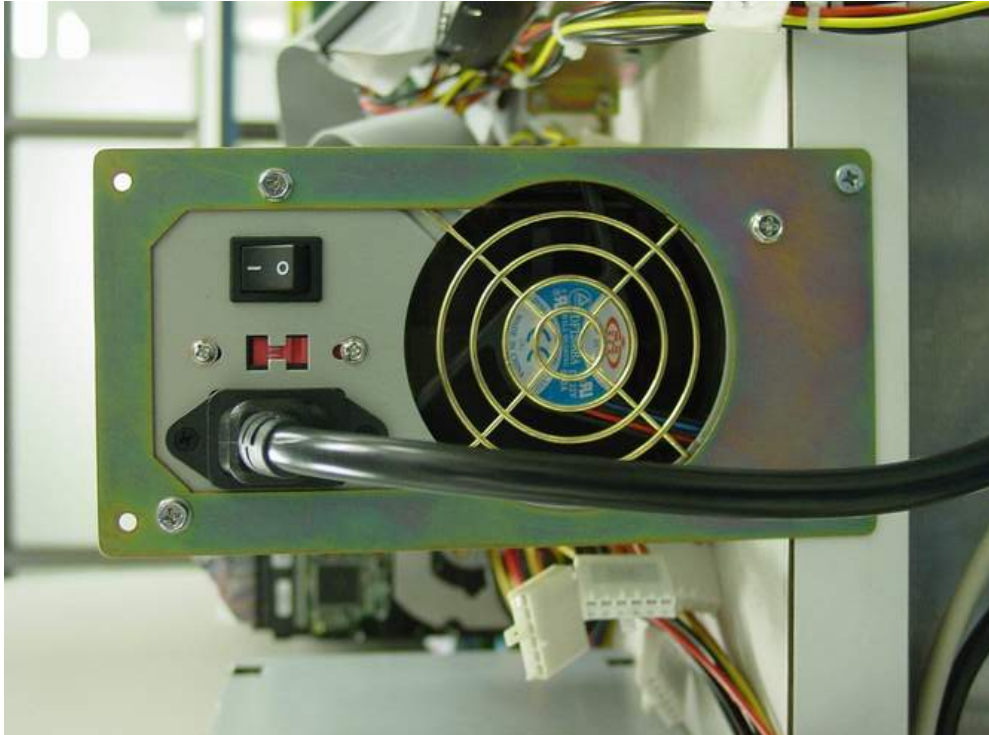
3. Until recently Conduant shipped all their Mark 5A units with an Antec True550 power supply. Some of these Antec power supplies do not have enough power for disk modules populated with Maxtor or Seagate drives. Recently, Conduant has been using the PC Power & Cooling Turbo-cool 510XE, which has heftier 12V performance and have proven to be OK. The triple-redundant supply in some of the early units built at Haystack has also been tested and found to be OK.

4. However, not all Antec True550 supplies are affected. Antec appears to have changed the specs on this model without changing the model number, so that only *some* Antec True550 supplies are affected. The difference is that the newer power supply, which is OK, has a "D" connector with a black plastic cover above the switch as shown in Figure 25. All good Antec supplies have this black plastic cover on the rear panel. The attached pictures should help to determine which supply you have.

Figure 1: Bad Antec True550; fan may also be labeled “Antec”, as in Figure 2

5. If you need to replace your power supply, Conduant recommends the PC Power & Cooling Turbo-Cool 510XE as a replacement. We at Haystack concur with this recommendation as the quality and reputation of these supplies is outstanding, and they come with a 5-year warranty.

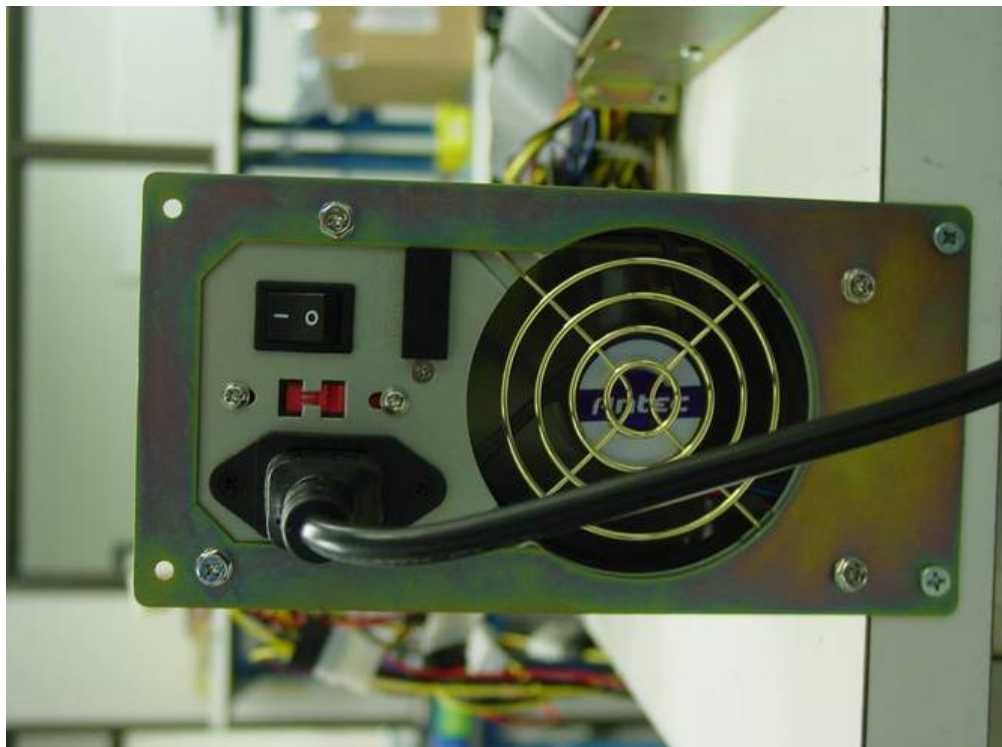
Figure 2: Good Antec True550; fan may not be labeled “Antec”

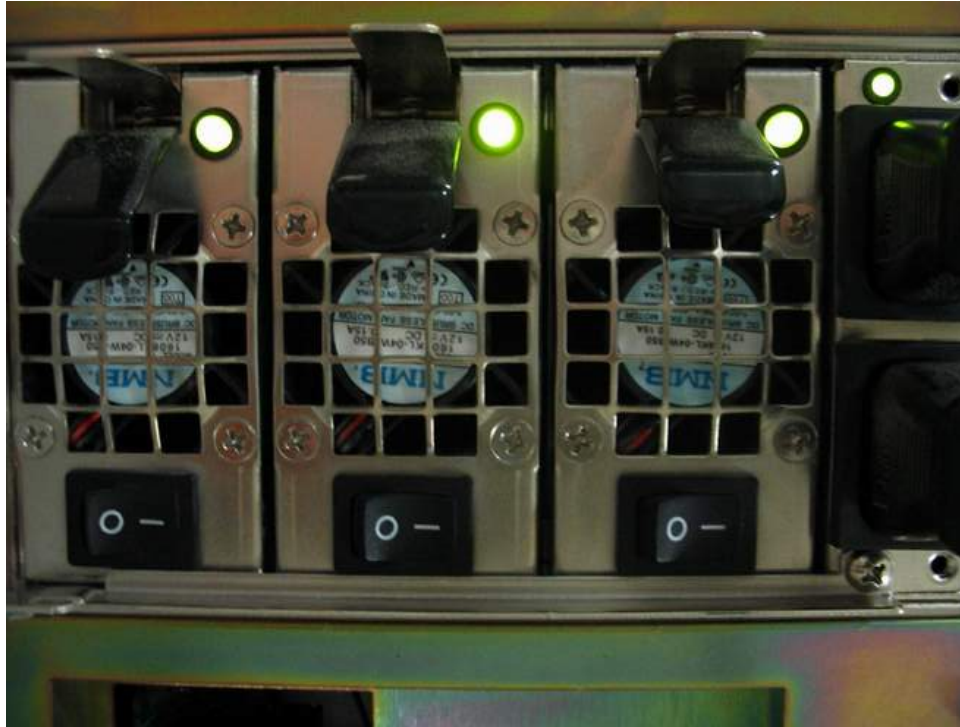
Figure 3: Triple-redundant supply - OK

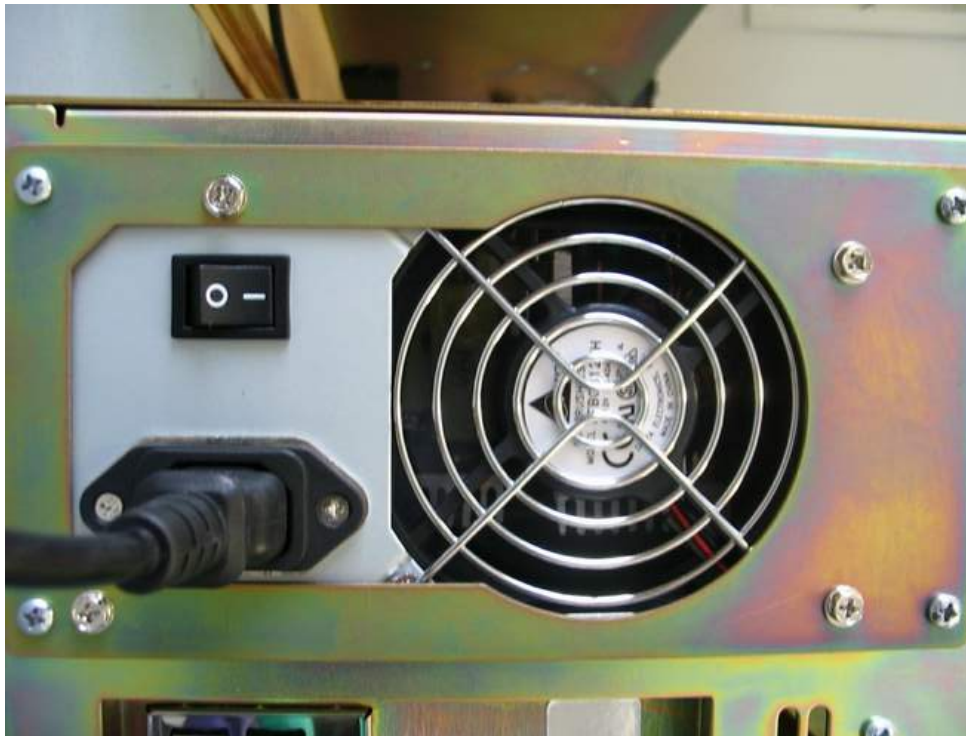
Figure 4: PC Power & Cooling Turbo-Cool 510XE - recommended replacement
